Manhole Inspection Summary

Manhole # S65Q__007MH

Insp Date: **4/24/08 2:20 PM**

Location Address: **1401 Anglesea Rd.**

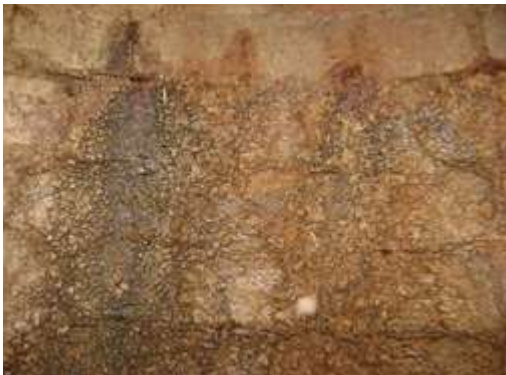
Defect 2

Infiltration: ☐ None ☒ **Joint** ☐ Cracks ☒ **Mortar** ☐ Roots ☐ Wall

Infiltration

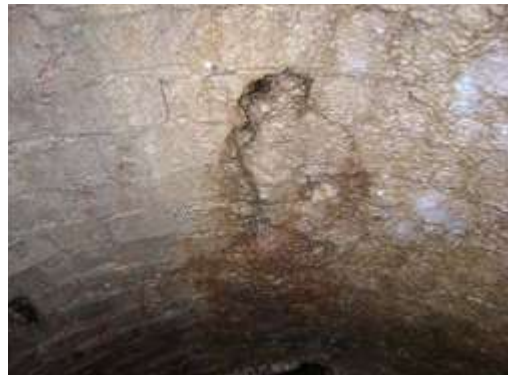
Defect 3

Infiltration: ☐ None ☐ Joint ☐ Cracks ☒ **Mortar** ☐ Roots ☐ Wall

Infiltration

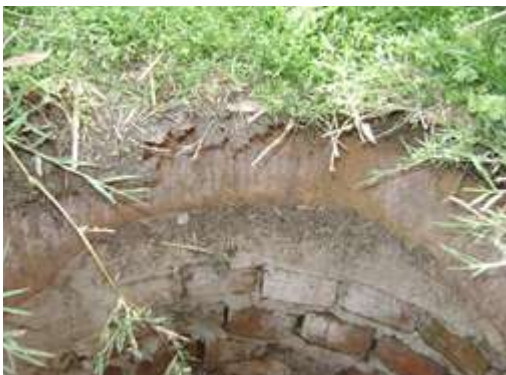
Defect 1

Condition: ☐ Sound ☐ Cracked ☐ Root Intrusion ☒ **Loose Brick** ☒ **Deteriorated**

Loose Bricks

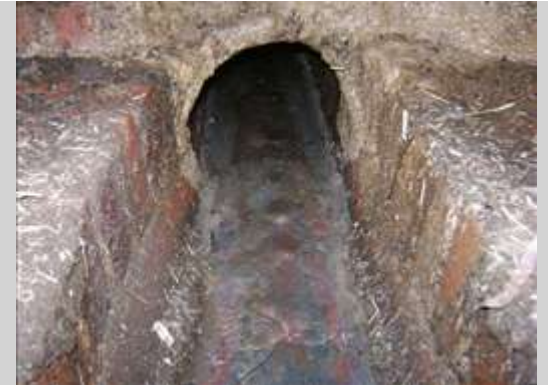
12 O'Clock Outflow

8 in. Circular Gravity Sewer
Pipe Out @ 12 O'Clock

Pipe Height: **8.4** (in.) Rod and Bar (Angled)
Pipe Material: **Clay** ☐ Pipe Lined
Invert Depth: **12.50** (ft.) Flow Characteristics: **Fast**
Deposits: ☒ None ☐ Mud ☐ Sludge ☐ Debris ☐ Grease
Silt Depth: (in.) Deposits Extent:
Infiltration: **None** Pipe Seal Cond: **Sound**

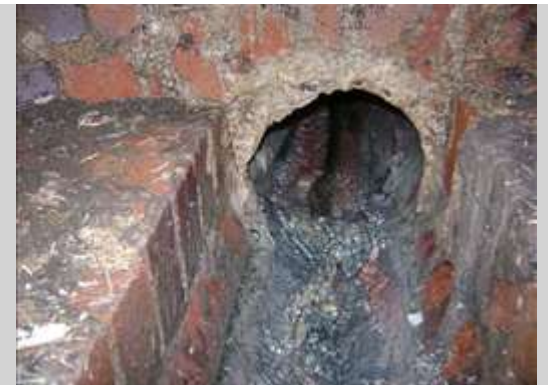
6 O'Clock Inflow

8 in. Circular Gravity Sewer
Pipe In @ 6 O'Clock

Pipe Height: **8.4** (in.) Rod and Bar (Angled)
Pipe Material: **Clay** ☐ Pipe Lined
Invert Depth: **12.33** (ft.) Flow Characteristics: **Fast**
Deposits: ☒ None ☐ Mud ☐ Sludge ☐ Debris ☐ Grease
Silt Depth: (in.) Deposits Extent:
Infiltration: **None** Pipe Seal Cond: **Sound**
